**FEDERAL ON-SCENE COORDINATOR'S REPORT
FOR THE
CAPITOL HILL SITE
WASHINGTON, DC**

**UNITED STATES
ENVIRONMENTAL PROTECTION AGENCY
REGION 3
PHILADELPHIA, PENNSYLVANIA**

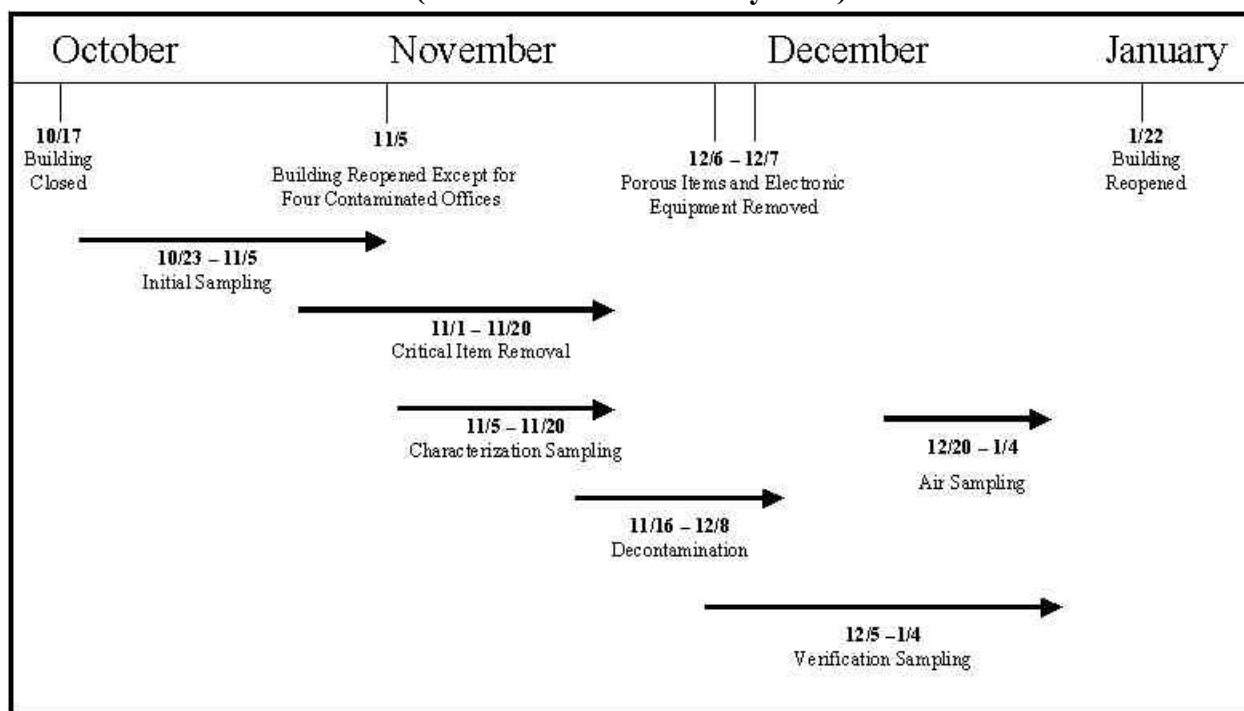
**Figure 3.2: Time Line of Major Events in the Longworth Building
(October 2001 to January 2002)**

Verification sampling occurred at different times with separate media types: HEPA, wipes, and air sampling. Verification wipe samples were collected on December 5 following an application of ClO₂ liquid. Verification air sampling occurred on December 20 and December 21 in the contaminated suites. Between December 6 and 7, all porous items and large electronic equipment were removed following treatment and transported off-site for disposal or further treatment. On January 3, suites 1630 and 1632 were re-isolated. Air sampling occurred in suites 1630 and 1632 on January 3 and January 4, respectively. On January 22, the Longworth Building was reopened.
